CHAPTER 2

NEW TEST SECTIONS

Five new test sections were constructed during the previous 2 years. The new test sections are:

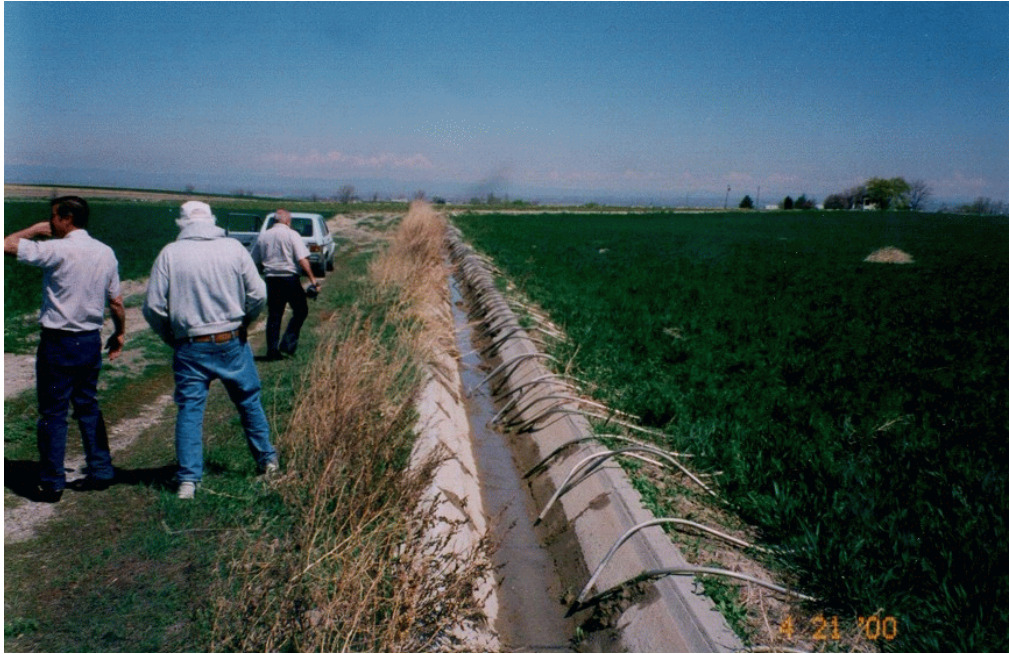
Photograph 1.—Existing concrete ditch with numerous cracks in the invert.

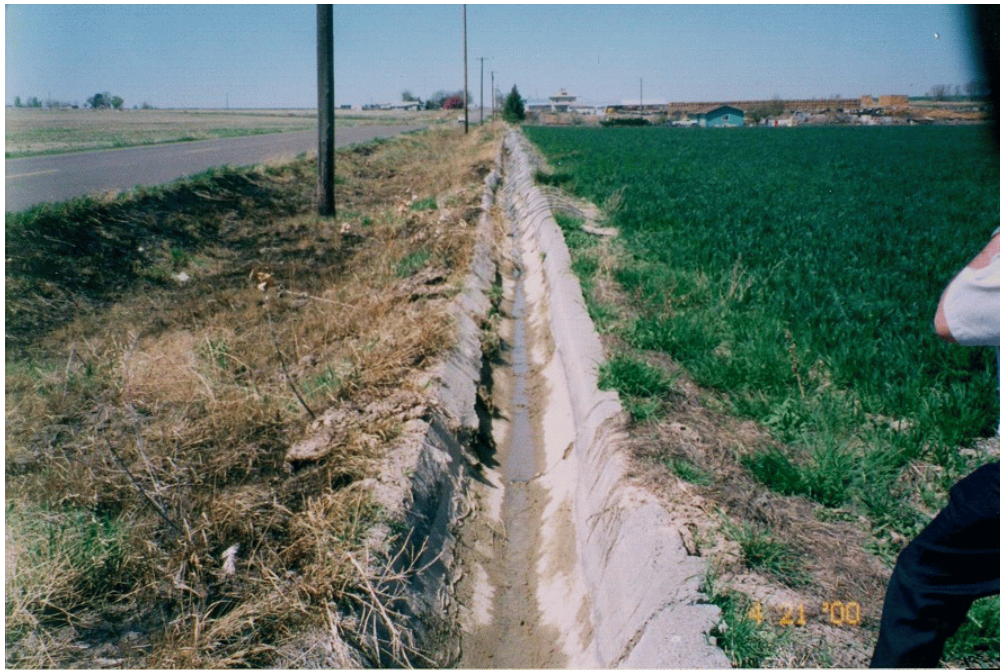
| Difficulties: | <p>Areas of broken concrete were covered with a double layer of polyurethane liner. The liner will stop the water seepage, and may prevent further collapse of the canal. This lining technique was very labor intensive, requiring 5-6 skilled workers from Canal Lining Systems, 1-2 chemists from Bayer Corporation, and 6-10 unskilled laborers who were hired locally. Once production began, the lining machine produced a 16-foot panel about every 2 minutes. The crew had to really hustle to keep up and could not stop for breaks. The lining machine was operated for 2 to 2½ hours at a time. When shutting down for lunch and at the end of the day, the dip tank was flushed with acetone. Because of the hard physical labor, the crew could work only 4-5 hours each day. Depending on carry distance, two crews might be needed per machine. Perhaps with four to six additional laborers, a full, 8-hour work day could be achieved. The polyurethane is quite messy and ruins the workers clothes; it is recommend that disposable coveralls and booties be provided.</p> |

Photograph 2.—Some sections of the existing concrete are severely cracked with offsets up to 4 inches.

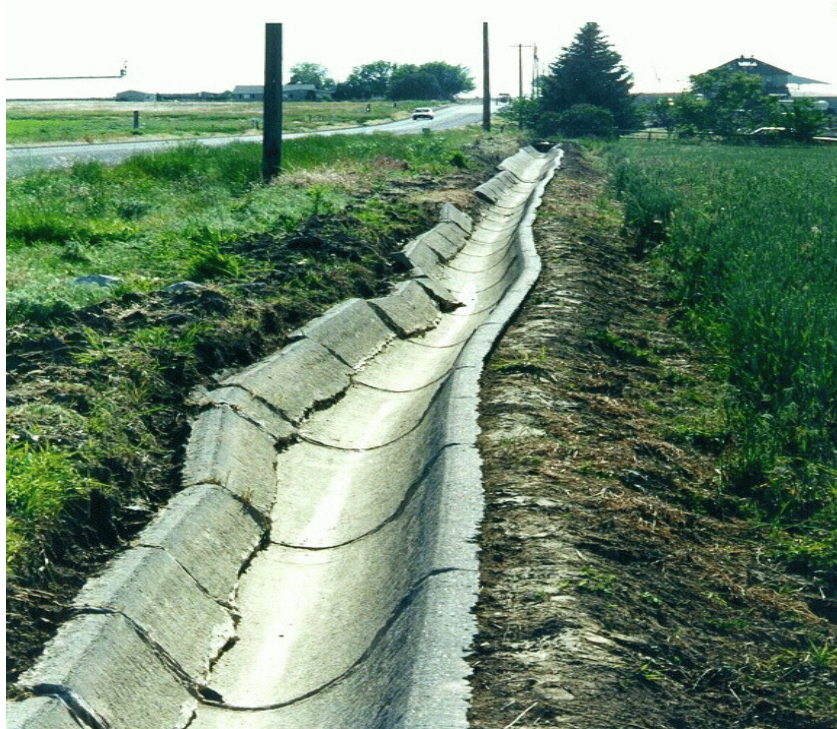
Photograph 5.—Severely cracked section after cleaning.

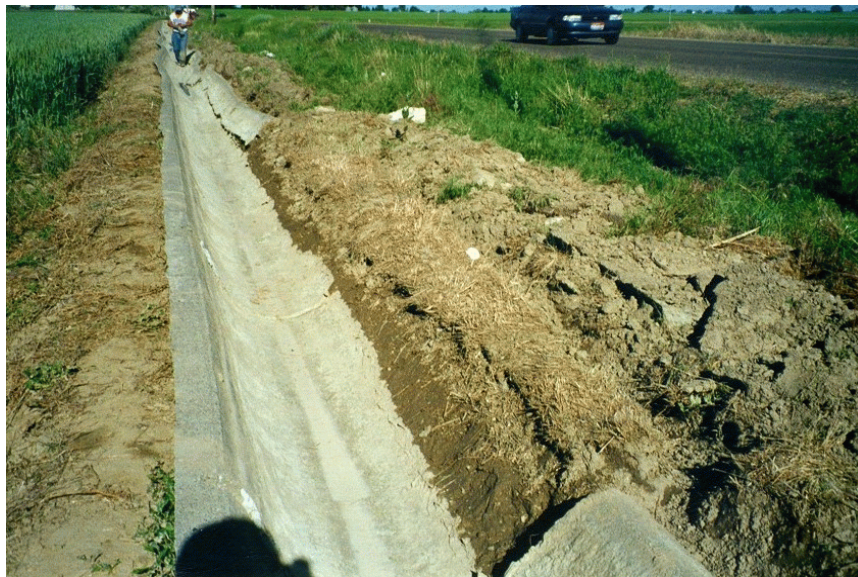
Photograph 6.—A section of the ditch where concrete panels are missing completely. A double layer of polyurethane liner will be installed over this section.

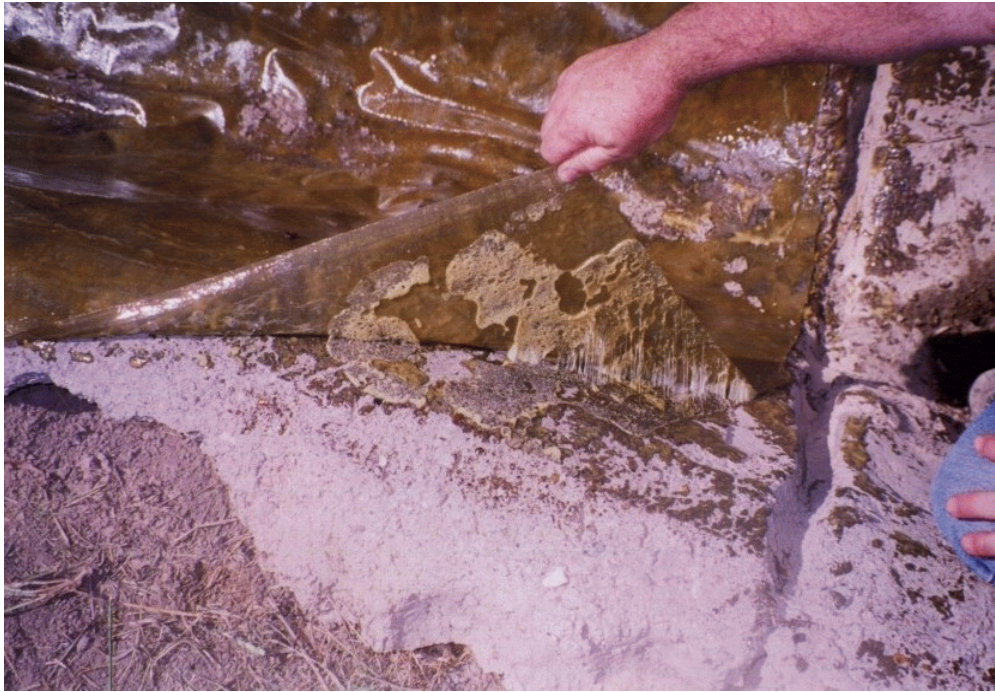
Photograph 13.—The liner is partially bonded to the old concrete. Foaming of the Polyurethane is caused by reaction with water

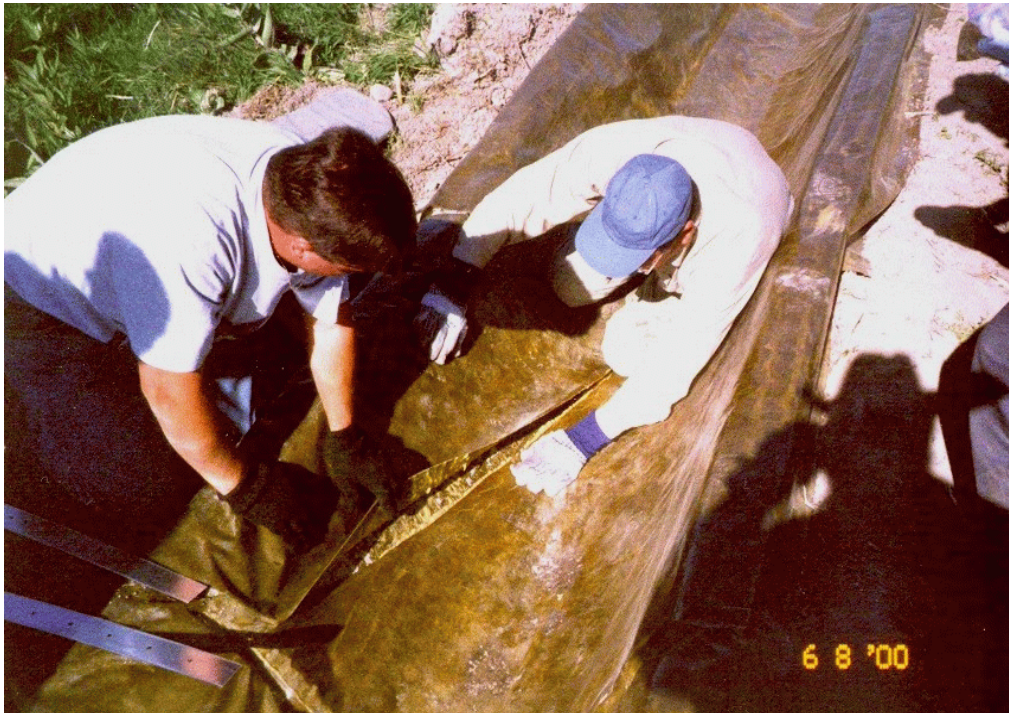
Photograph 14.—Large wrinkles were cut open and patched.

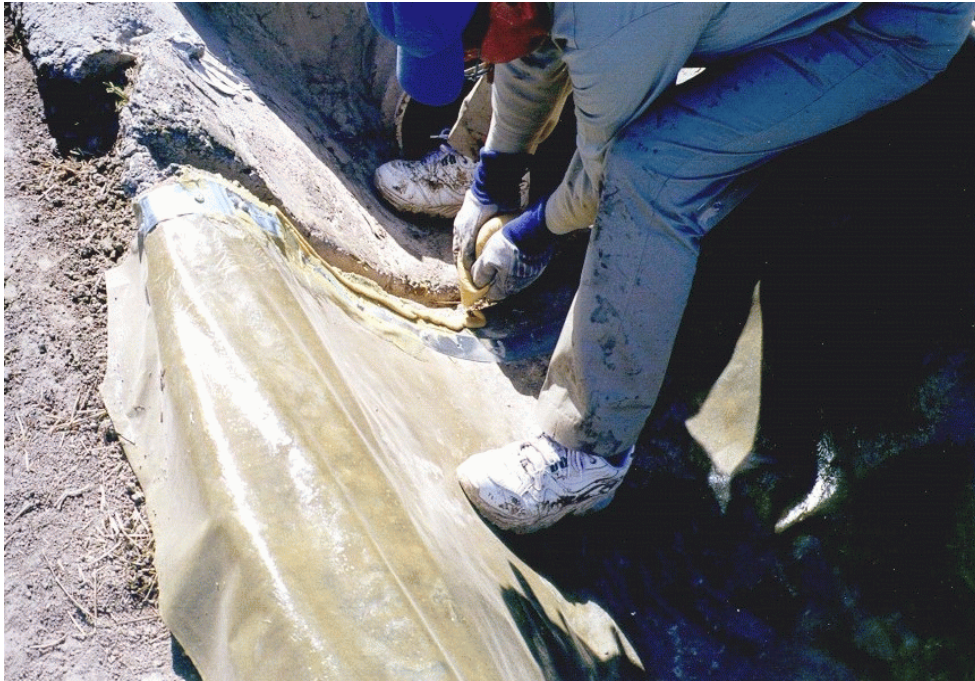
Photograph 15.—The chemists used a polyurethane patching compound to repair problem areas.

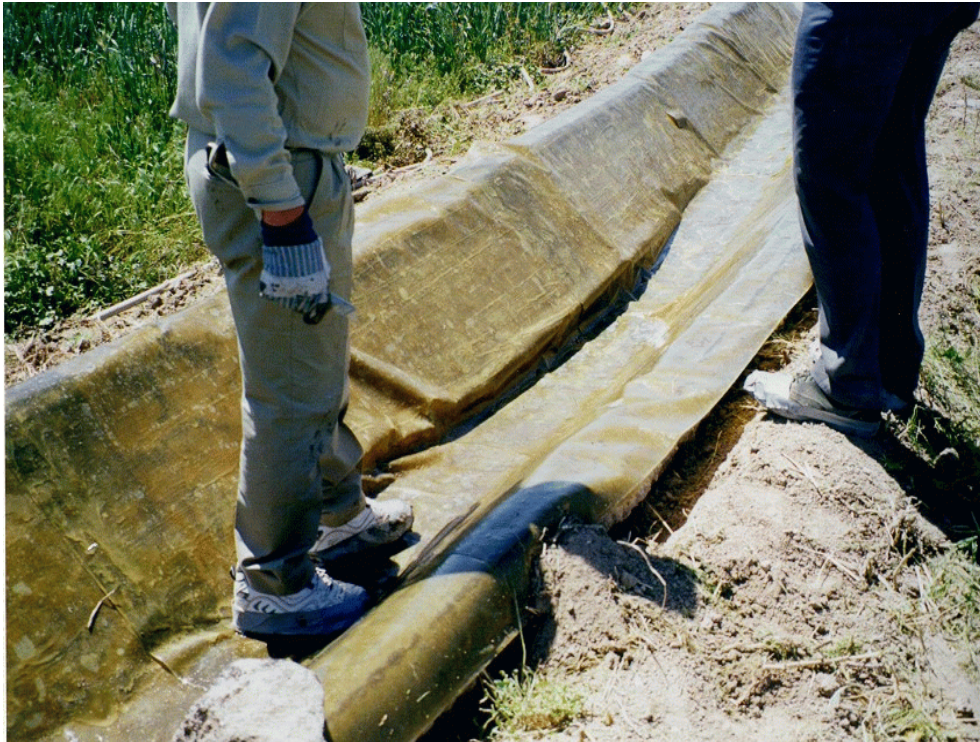
Photograph 21.—The polyurethane liner conforms to concrete with offsets in the invert of up to 4 inches. The liner is ready to be secured by backfilling the anchor trench.

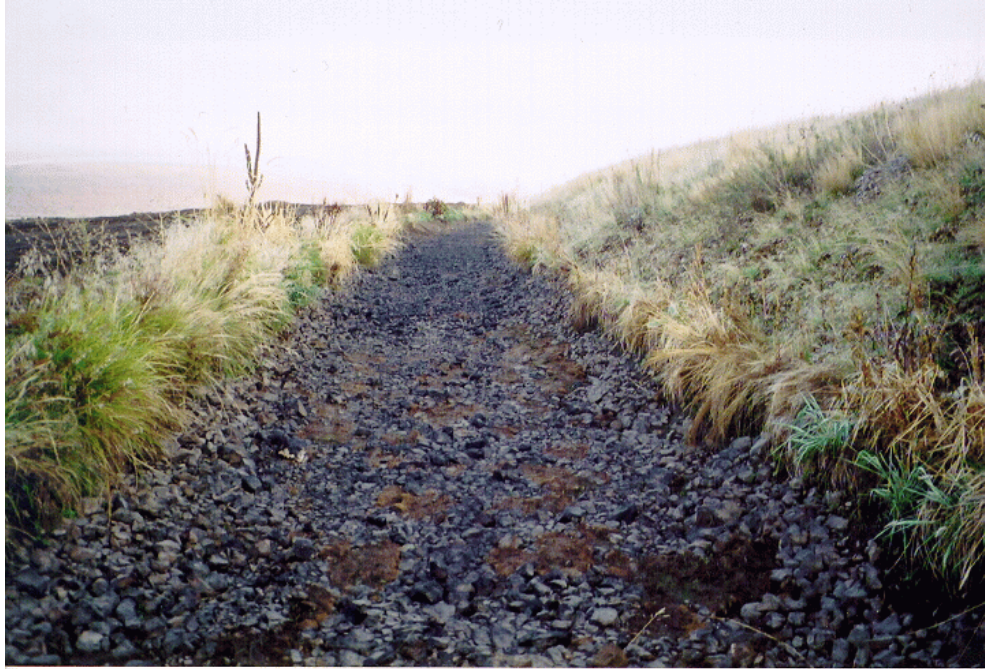
Photograph 1.—Preconstruction conditions at Lewiston Orchards.
Subgrade consists of angular volcanic basalt.

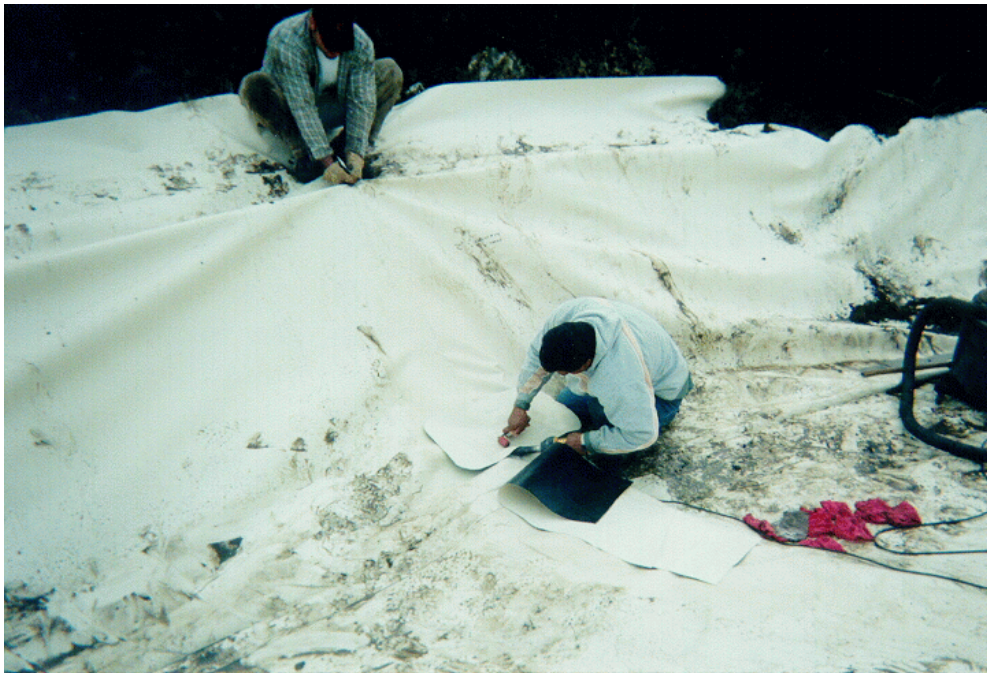
Photograph 18.—The master welder places a large patch over a problem seam.

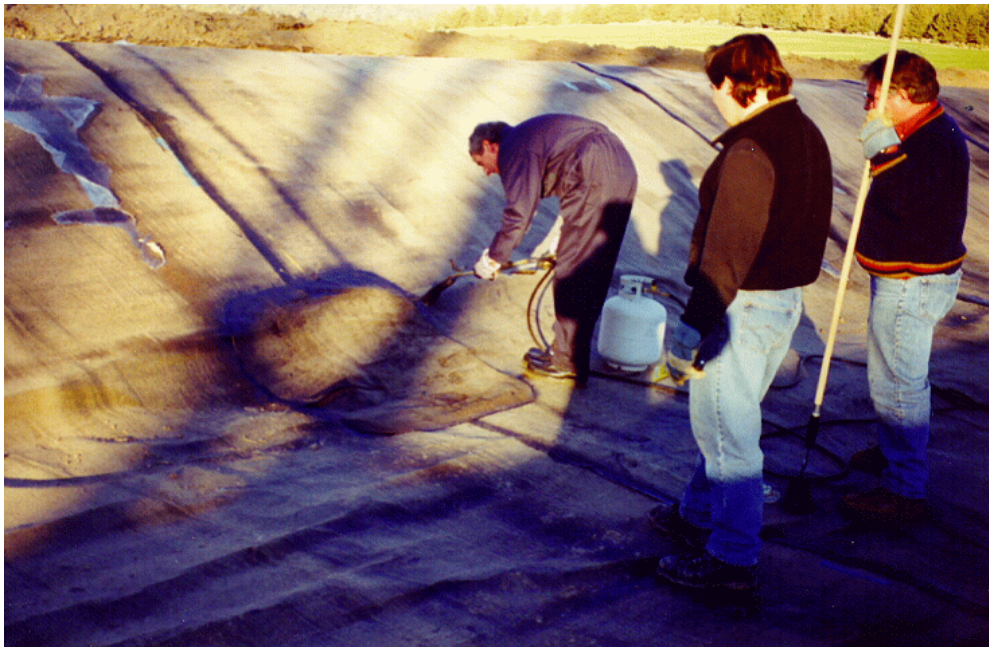
| Difficulties: | The subgrade was quite irregular, with offsets of up to 6 inches. Seaming over these large offsets was challenging. |

Photograph 19.— Seamer places a large patch over a wrinkled seam caused by uneven subgrade.

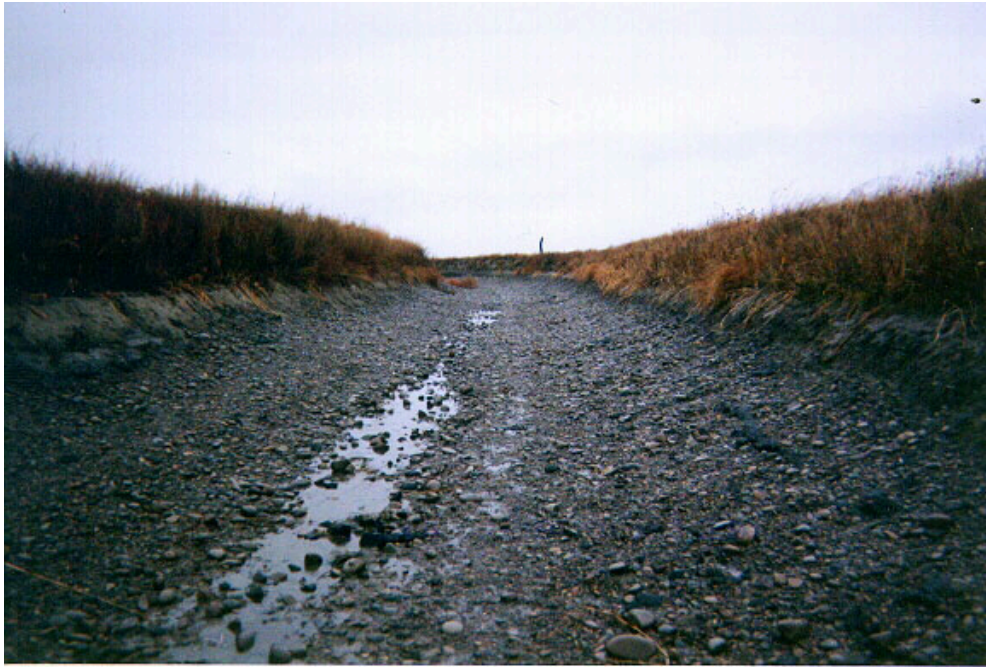
Photograph 1.—Canal subgrade where geotextile cushion will be used. Small pieces of the old asphalt lining can be seen in the right foreground.

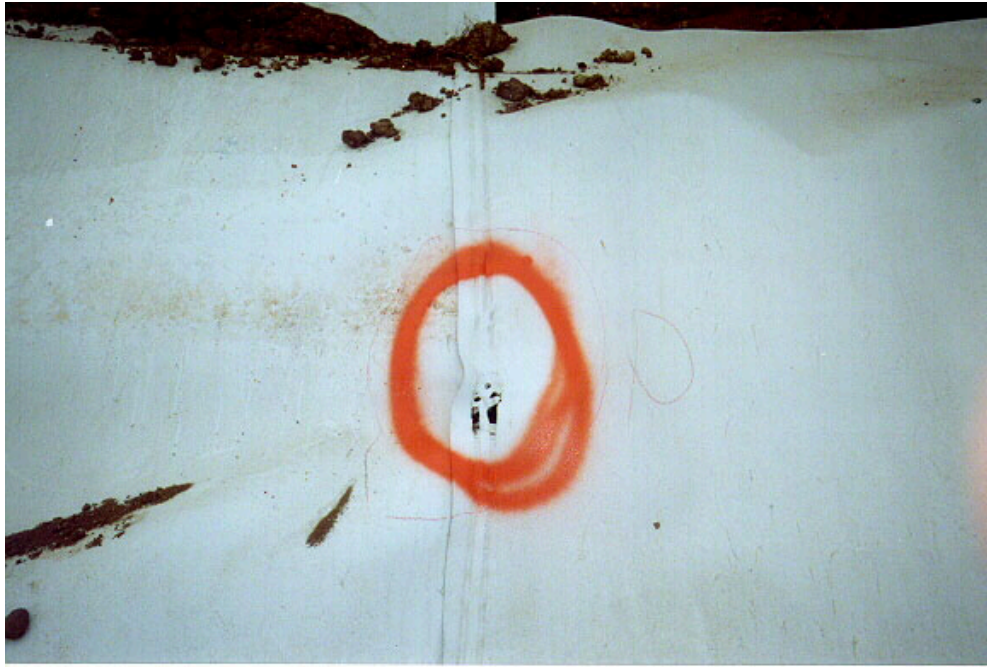
Photograph 23.—Damage caused by wedge welder that needs to be repaired.

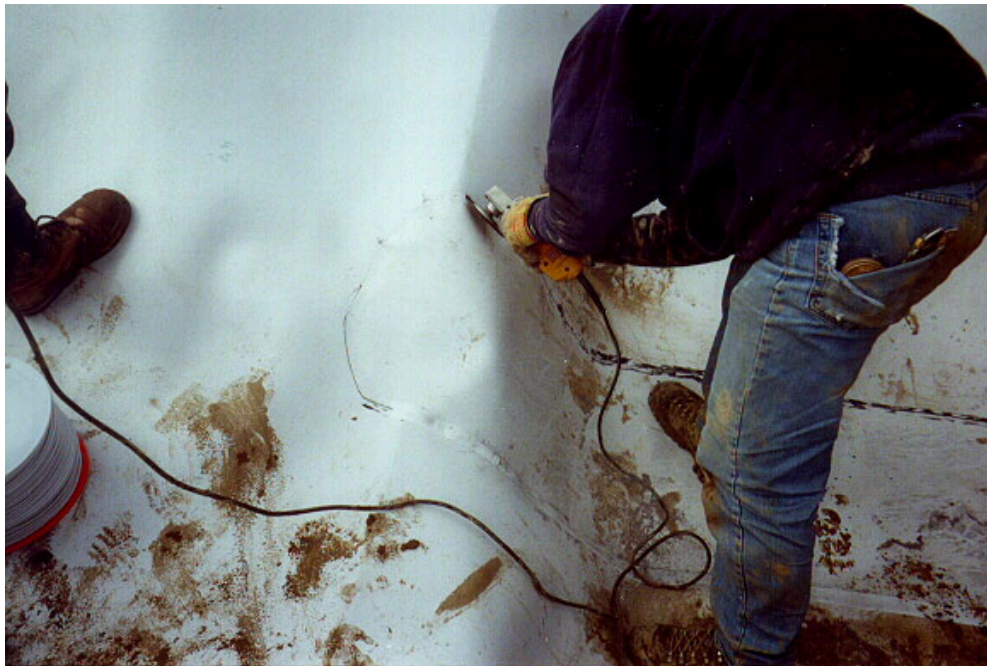
Photograph 24.—After tacking the patch in place with a hot-air gun, edges of the patch are ground off.

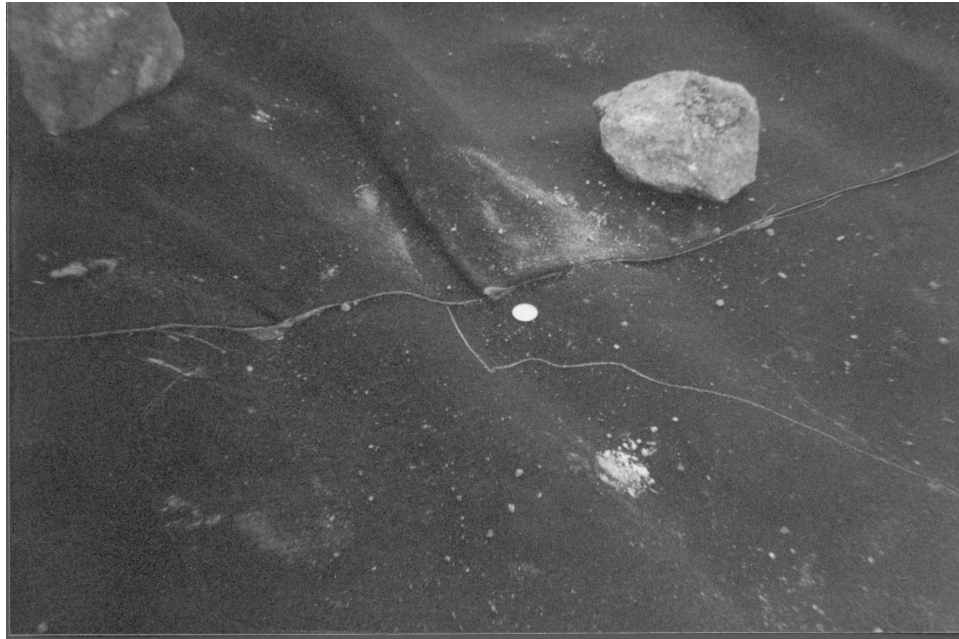
Photograph 17.—Lower portion of Photograph shows factory seam in the upper geotextile. Fishmouth in the seam has been folded over and glued shut.
